1. Cutting Plate Lifting group

During the season 2014/2015 some claims have arisen from the market concerning the breakage of axle for cutting deck lifting (**Pic.1, part 21**).

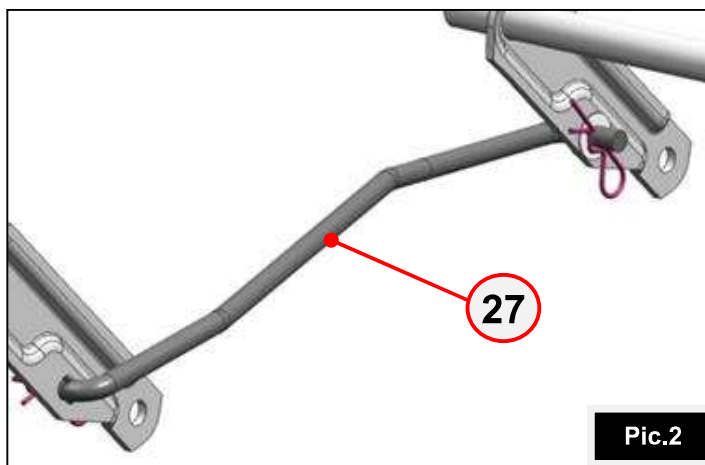
1.a – Connecting rod between lever and axle for cutting deck lifting (**Pic.2, part 27**)

The rod diameter of the rod has been increased from 6.8 to 9 mm and the adjustment pin removed (**Pic.1, part A**) since the adjustment of longitudinal position of the cutting deck has never been necessary. In **Pic. 2** you can see the "new" connection between the front lever and rear lifting axle.
